Digest of available  
enhancements

# A320 Family

Version 11

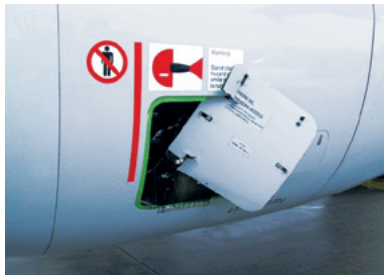
Damage caused by partial loss of Oil Filler Door

This enhancement can be embodied by: **SB A320-71-1061** – Fan cowl doors – Introduce an improved oil filler door latch design on IAE engine.

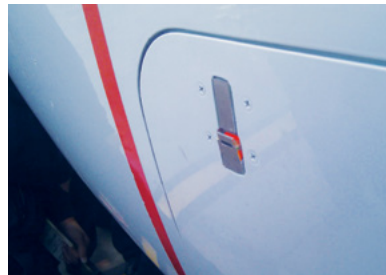
Pre-mod showing Refuel Filler Door not fully closed leading to scooping effect
