Digest of available
enhancements

A320 Family

Version 12

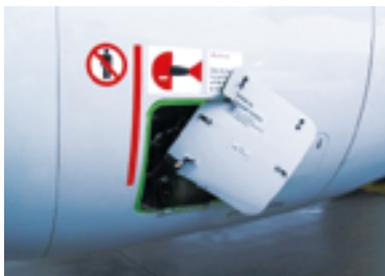
Damage caused by partial loss of Oil Filler Door

This enhancement can be embodied by: **SB A320-71-1061** – Fan cowl doors – Introduce an improved oil filler door latch design on IAE engine.

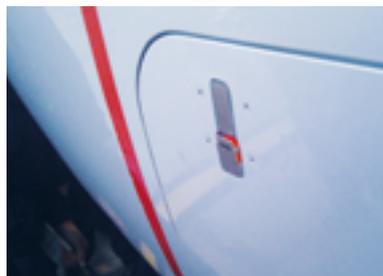
Pre-mod showing Refuel Filler Door not fully closed leading to scooping effect

Since issuance of **SB A320-71-1061**, it was determined that incorrect rigging may have been accomplished during production on limited batch on post mod oil servicing doors, which could impair effectiveness of **SB A320-71-1061**. Goodrich Aerostructures issued **VSB V2500-NAC-71-0332** providing instructions for inspecting and rigging of affected doors.
